New York State Department of Transportation

Red Flag NB2258W014

BIN: 1065318

Location: Span 58, Stringer S2 at Pier 57 above 3rd Avenue EB Service Road at the intersection of 60th Street.

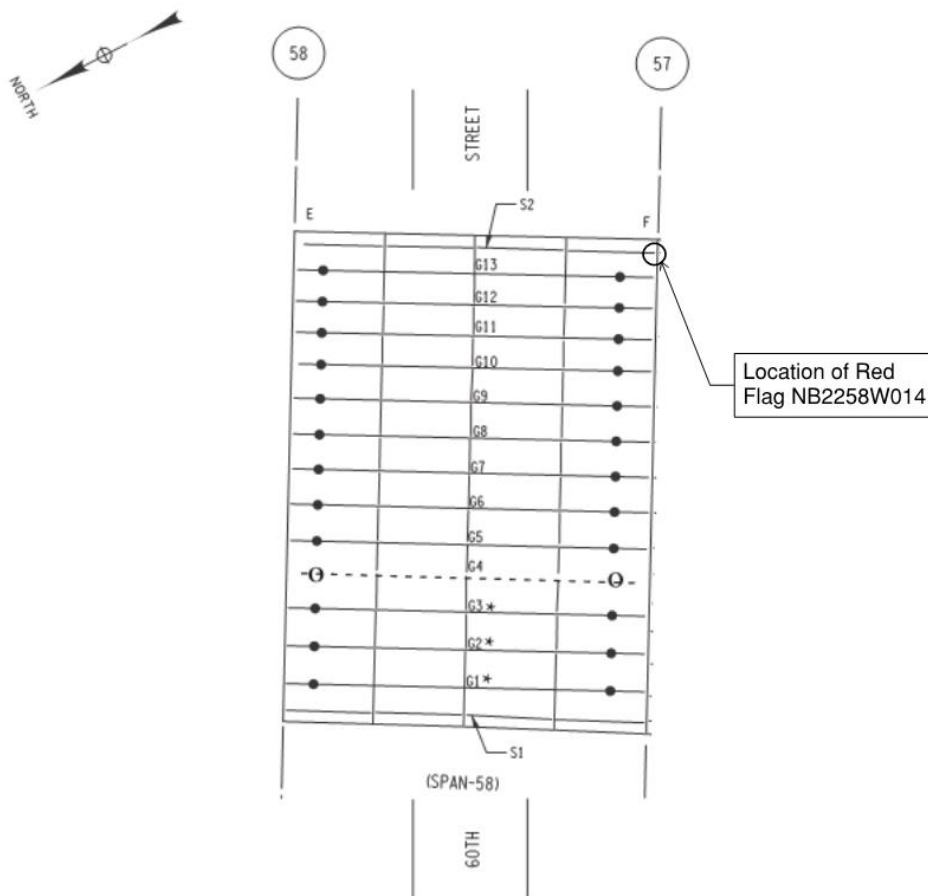
Flag PhotographsPhoto Number: **1**Photo Filename: **22_Flag Location Plan.jpg**Gowanus Expressway
2022 Biennial Inspection - Field SketchBIN: 1065318Team: AA/TSDate: 09/22/2022Span: 58Location: Stringer S2 at Pier 57**Red Flag Location Plan**

**Attachment Description: Red Flag Location Plan**

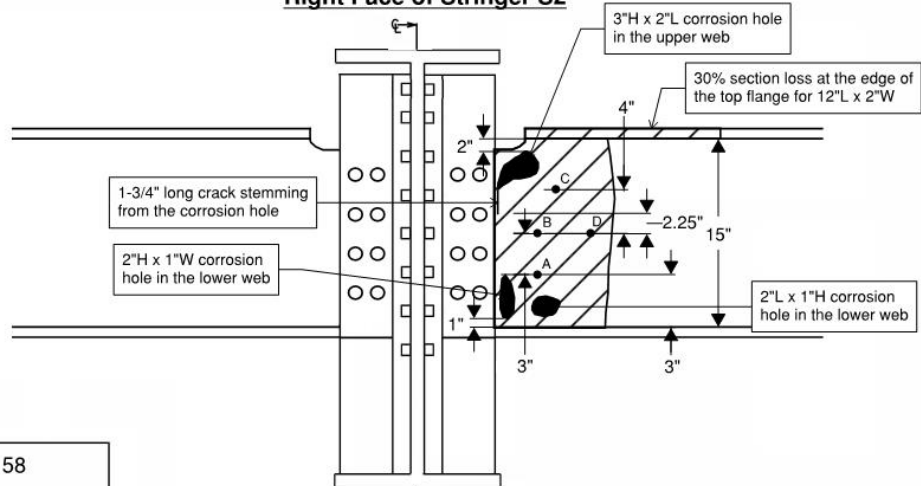
Photo Number: 2

Point	D-Meter Readings (in)	Calculated Section Loss
A	0.18	55%
B	0.24	40%
C	0.17	58%
D	0.32	20%

Original web thickness = 0.40" (measured in field)

$$(0.18 \times 1") + (0" \times 2") + (0.24 \times 3") + (0.17 \times 2.25") = 1.283 \text{ in}^2$$

$$[(13" \times 0.40") - 1.283 \text{ in}^2] / (13" \times 0.40") \times 100 = 75\% \text{ section loss}$$

- The left side bottom flange of the stringer exhibits 30% section loss at the edge of the flange for 24"L x 2"W.
- The length of this portion of Stringer S2 between Pier 57 and ID1 is approximately 18ft.
- The distance from the edge of the roadway to the right fascia steel plate is approximately 26".
- The distance from the right face of the Stringer S2 web to the right fascia steel plate is approximately 26".

Attachment Description: Red Flag Condition Sketch

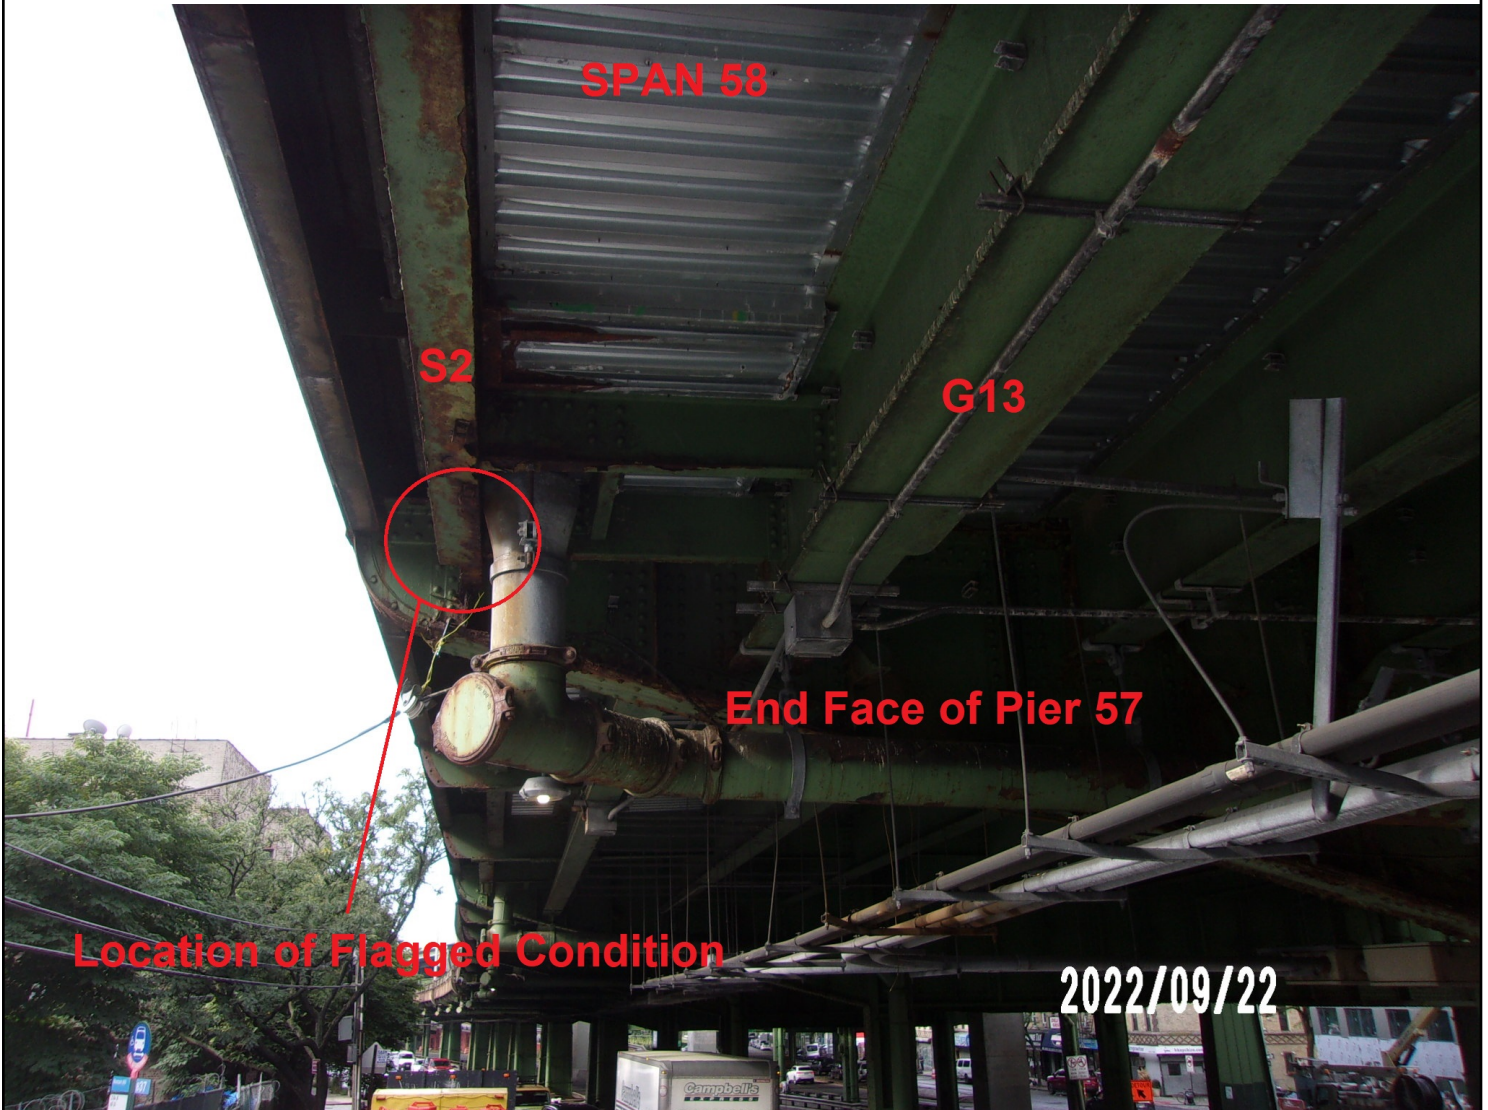
Photo Number: 3

Attachment Description: General view of the flagged condition at Stringer S2 in Span 58 at Pier 57. Looking Begin.

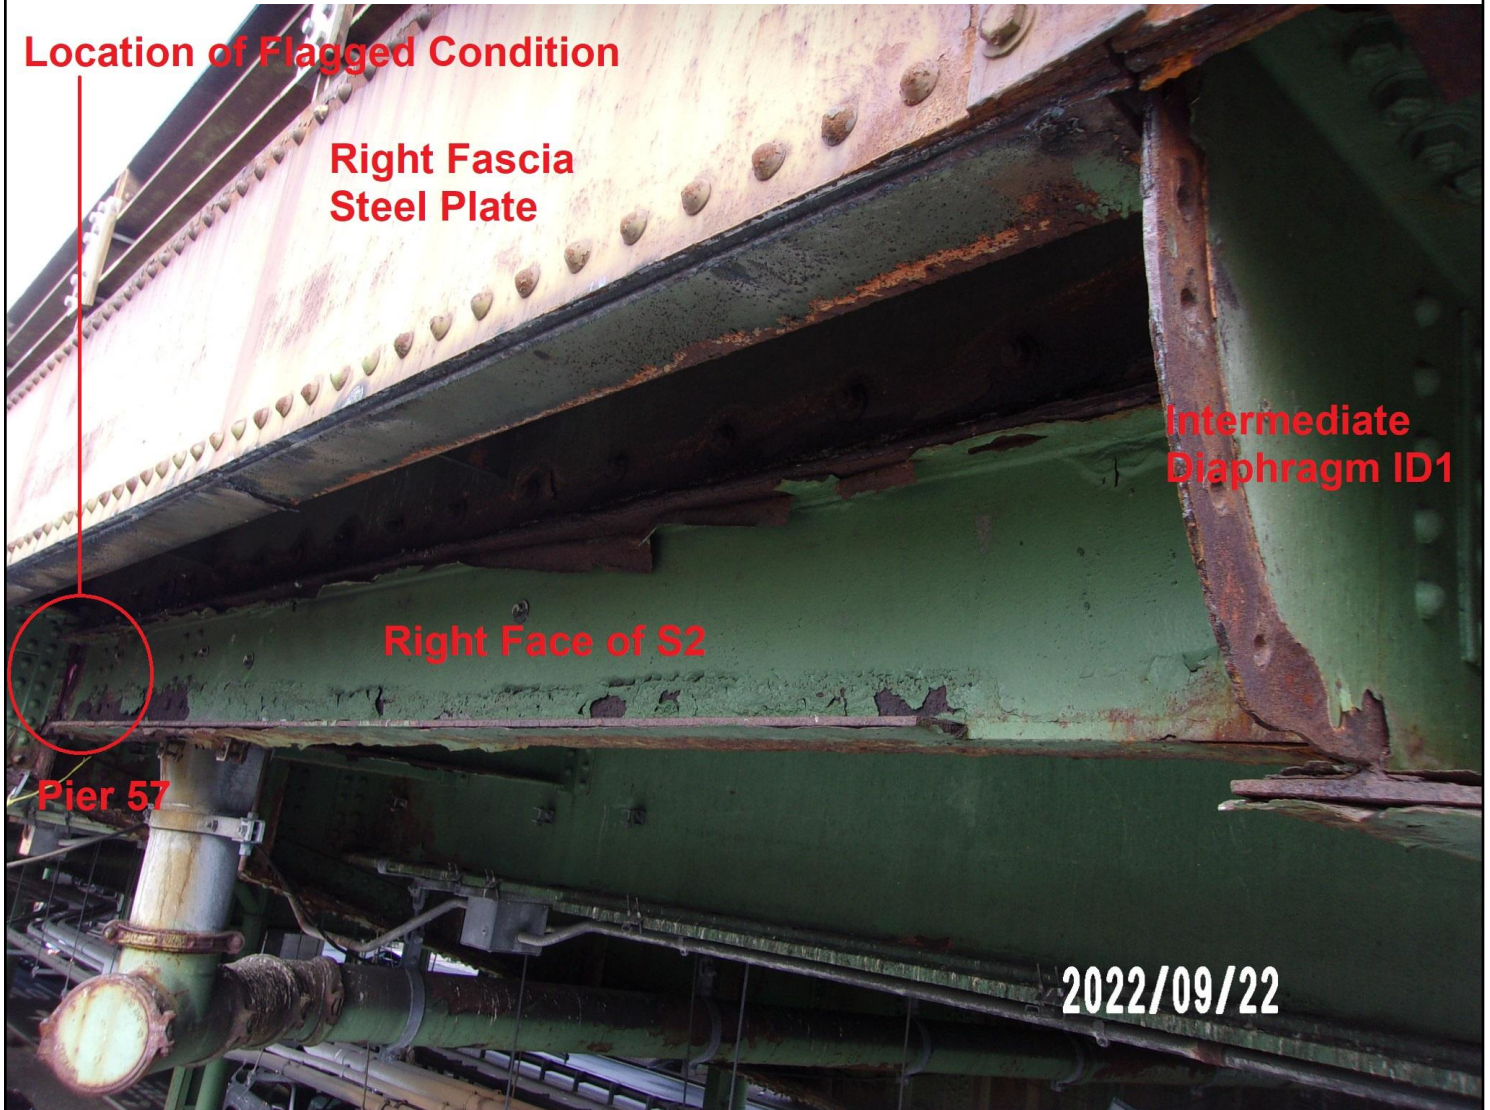
Photo Number: 4

This portion of Stringer S2 is approximately 18ft long from Pier 57 to Intermediate Diaphragm #1 (ID1) (Photo 4). The stringer at the connection to ID1 exhibits up to 1/16" section loss for the full height of the web for 2" wide along the connection angles at both faces of the stringer (Photo 10). Given the significant section loss and vertical crack in the stringer web at the connection angle at Pier 57, the stringer does not pose any safety concerns of falling onto pedestrians or vehicular traffic below at the time of inspection.

Attachment Description: General view of Stringer S2 in Span 58 between Pier 57 and ID1. Looking Begin and Left.

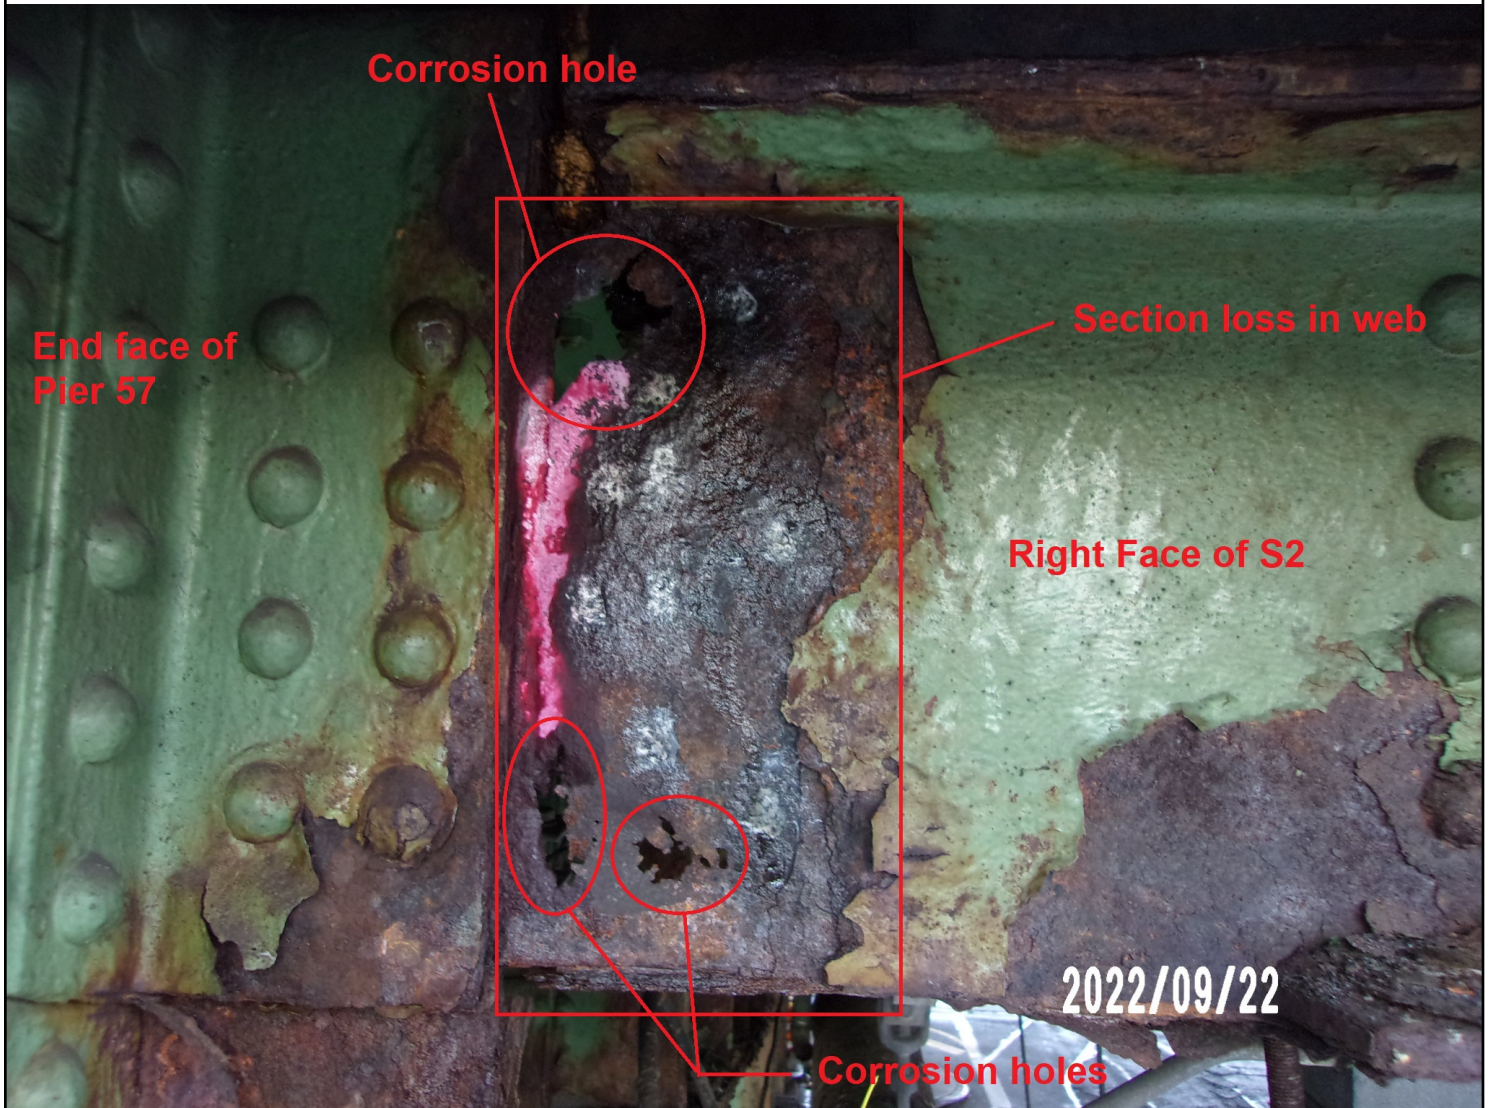
Photo Number: 5

The end of Stringer S2 in Span 58 at Pier 57 exhibits section loss for the full web height for 6" wide along the connection angles with remaining thickness measured (RTM) ranging from 0.17" to 0.32" resulting in approximately maximum 58% section loss (Photos 5 and 6). The lower stringer web above the bottom flange exhibits two corrosion holes for 2"H x 1"W and 2"L x 1"H. The upper stringer web near the top cope exhibits one corrosion hole for 3"H x 2"L with 1-3/4" long vertical crack stemming from the bottom of the corrosion hole (Photo 7). The overall shear web area section loss is approximately 75% for this fascia stringer/curb girder.

Attachment Description: The right face of Stringer S2 in Span 58 at Pier 57. The end of the stringer exhibits maximum 58% section loss for the full web height along the connection angle with corrosion holes in the upper and lower web. Looking Left.

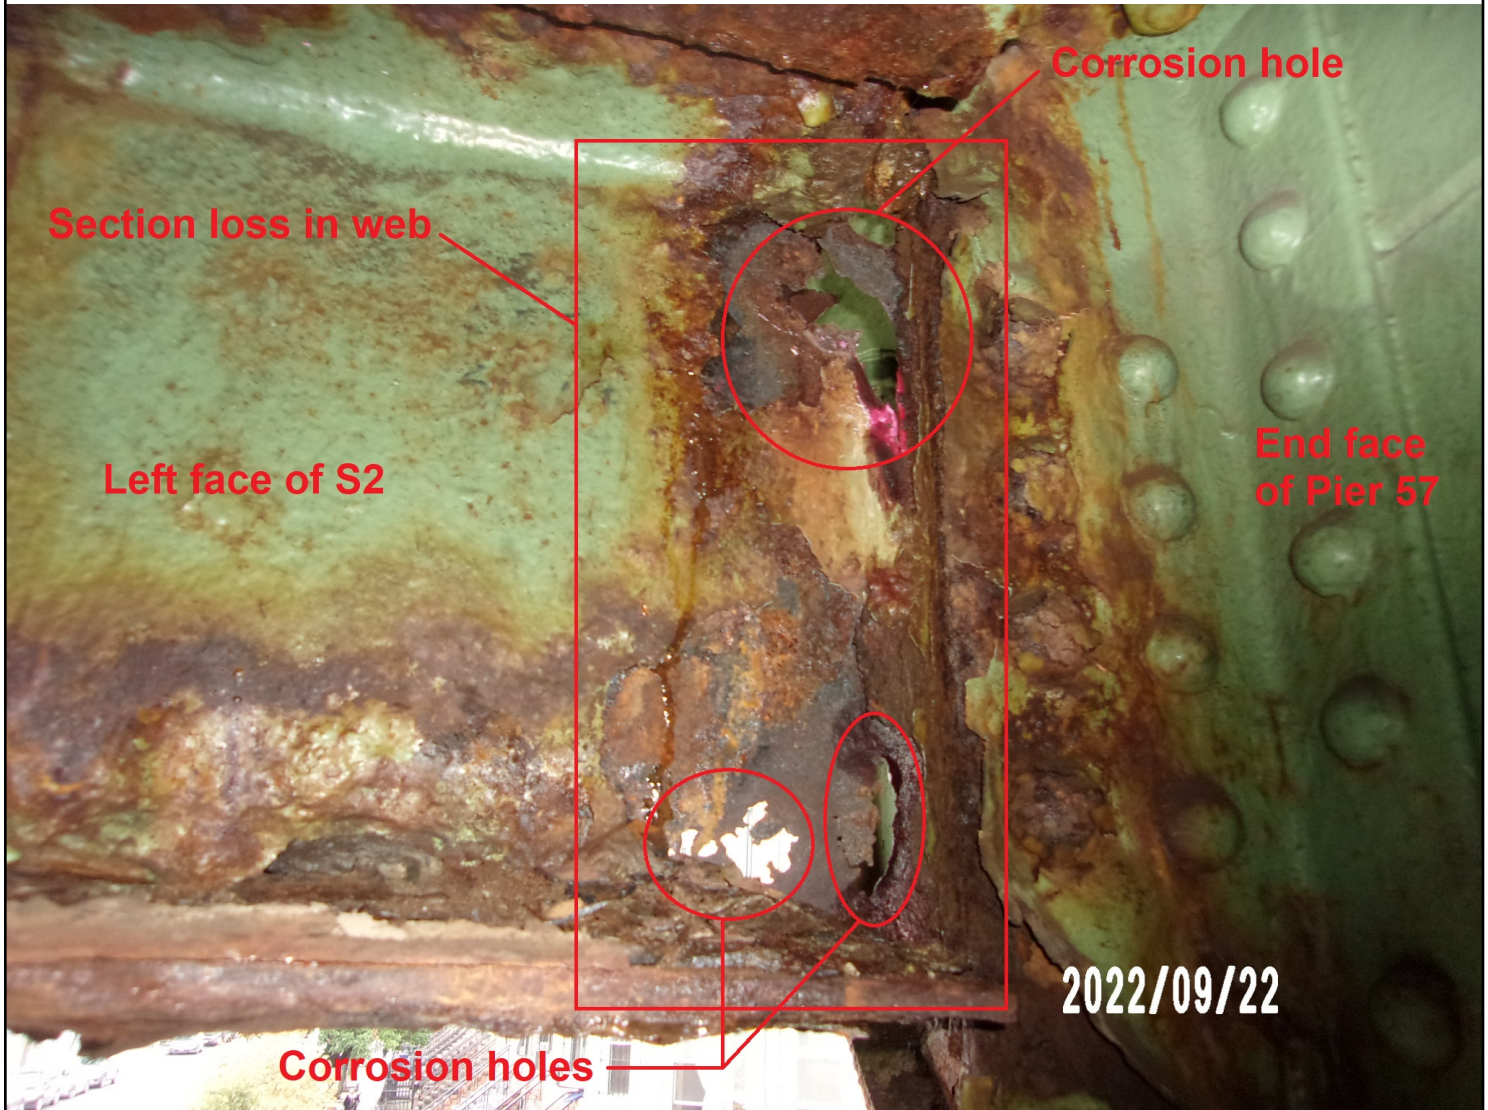
Photo Number: 6

Attachment Description: The left face of Stringer S2 in Span 58 at Pier 57. The end of the stringer exhibits maximum 58% section loss for the full web height along the connection angle with corrosion holes in the upper and lower web. Looking Right.

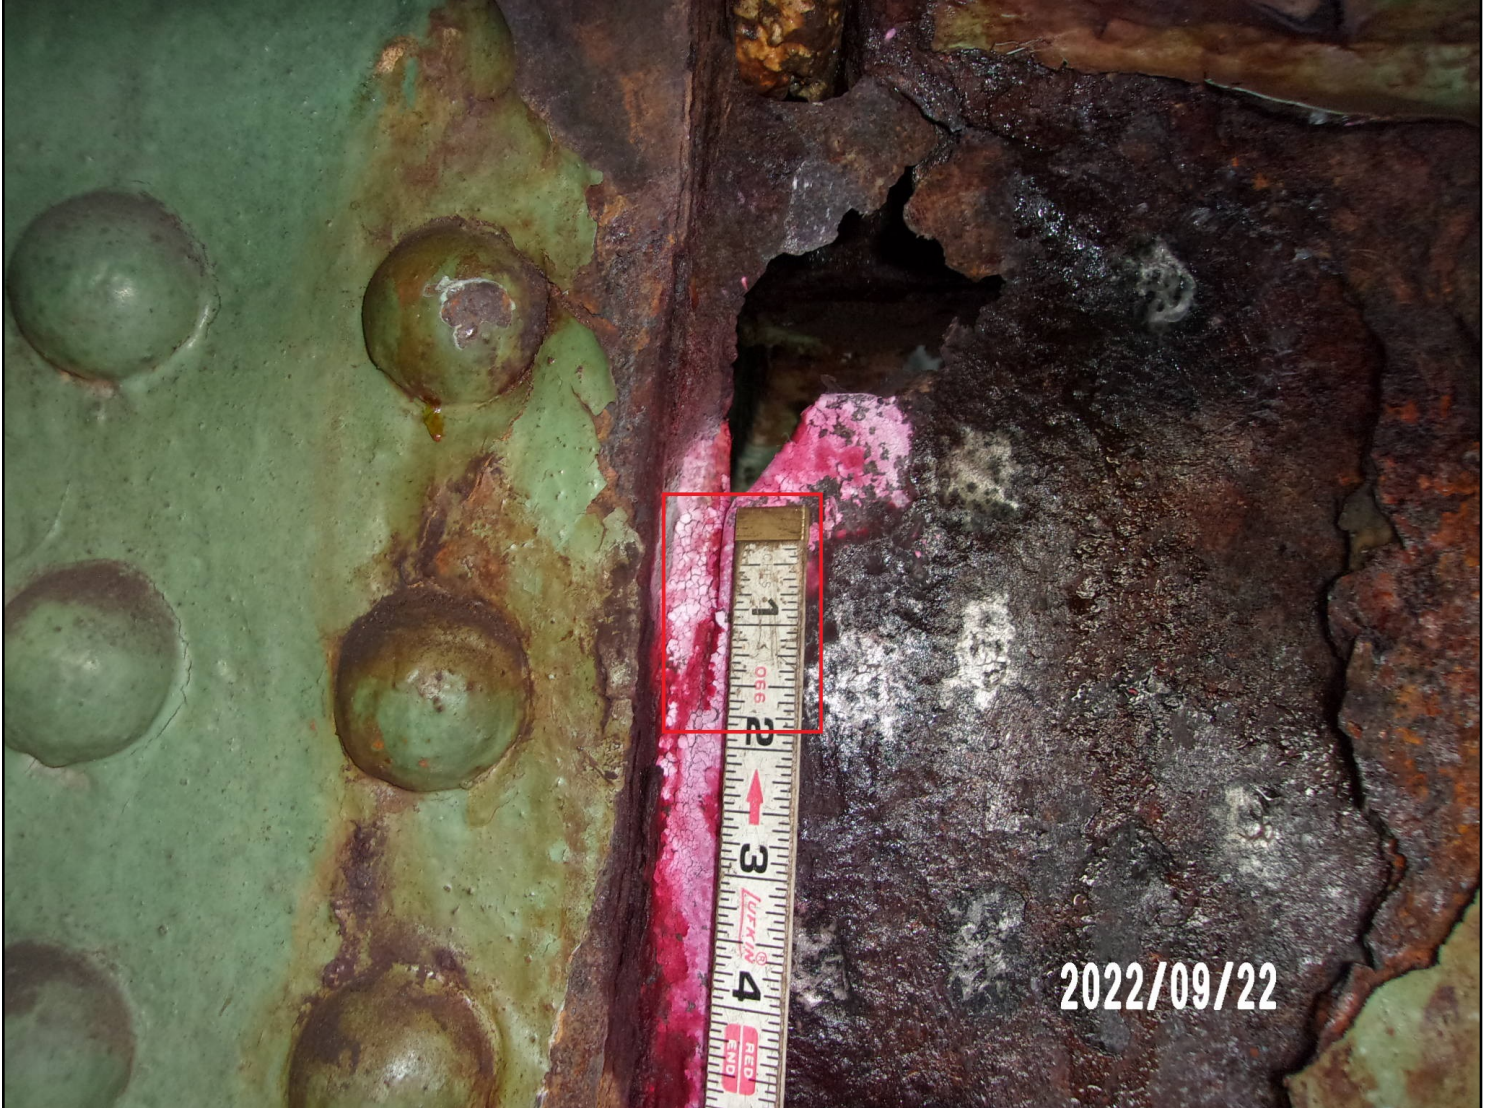
Photo Number: 7

Attachment Description: The right face of Stringer S2 in Span 58 at Pier 57. The stringer web exhibits 1-3/4" long vertical crack stemming from the bottom of the corrosion hole at the upper web. Looking Left.

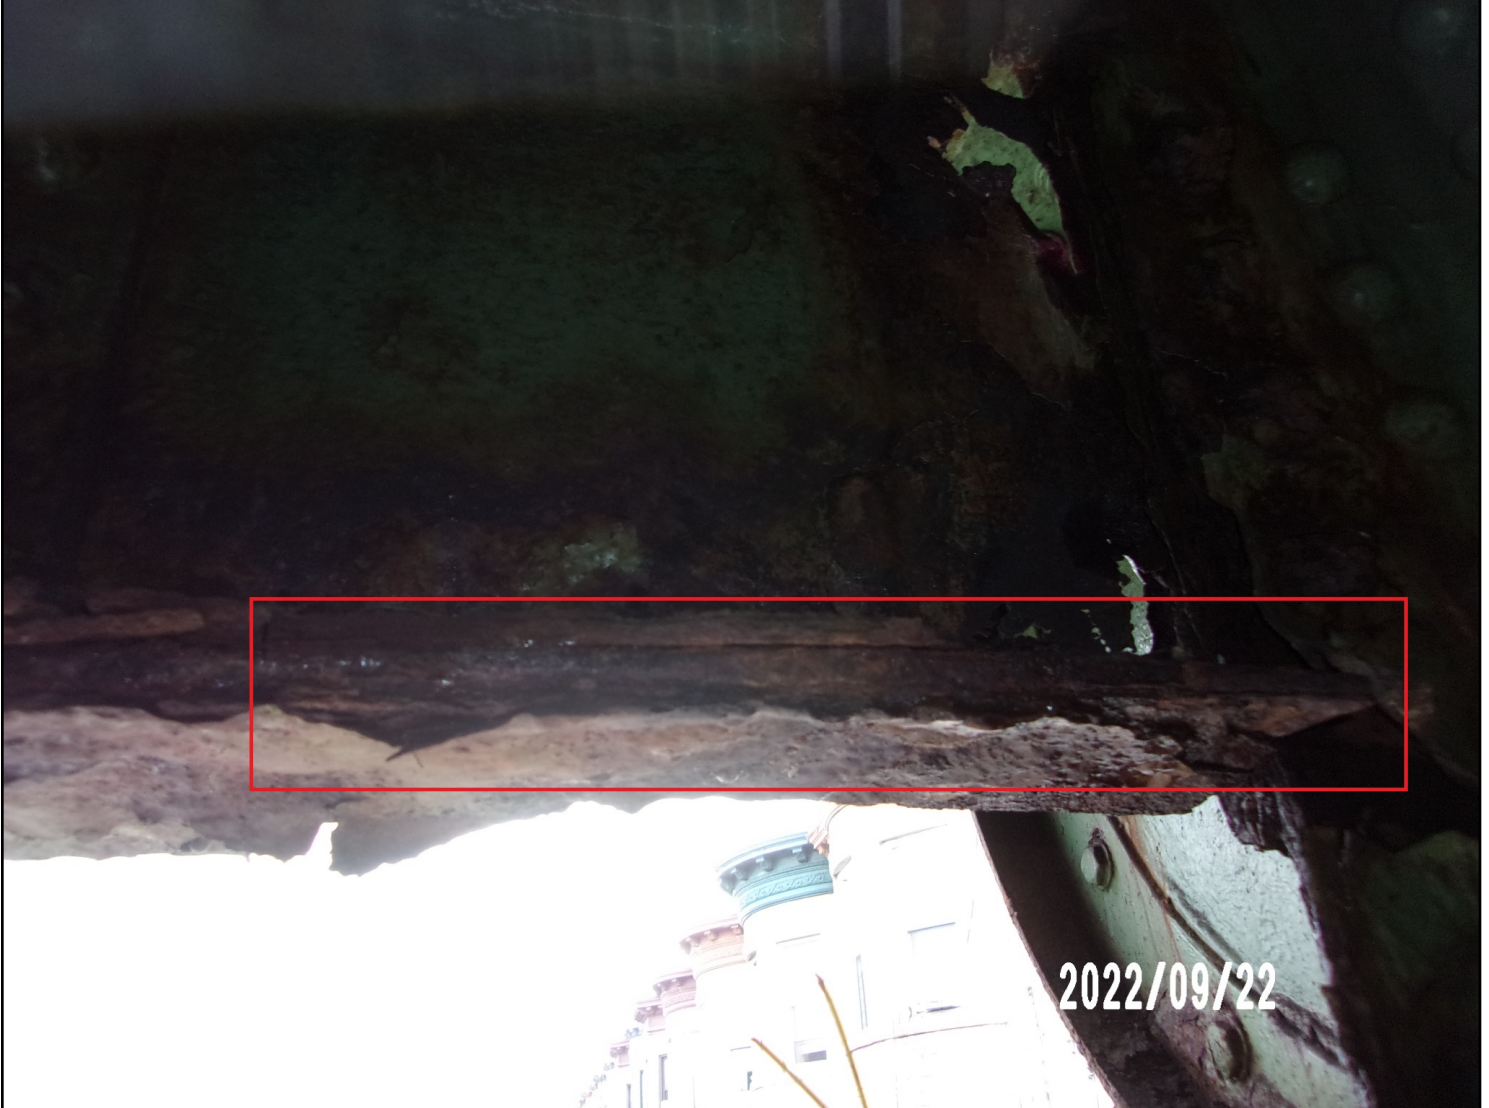
Photo Number: 8

Additionally, the left side bottom flange exhibits 30% section loss at the edge of the flange for 24"L x 2"W (Photo 8). The right side top flange exhibits 30% section loss at the edge of the flange for 12"L x 2"W (Photo 9). (refer to Red Flag Condition Sketch Photo 2 for more details).

Attachment Description: The left face of Stringer S2 in Span 58 at Pier 57. The left side bottom flange exhibits 30% section loss at the edge of the flange. Looking Right.

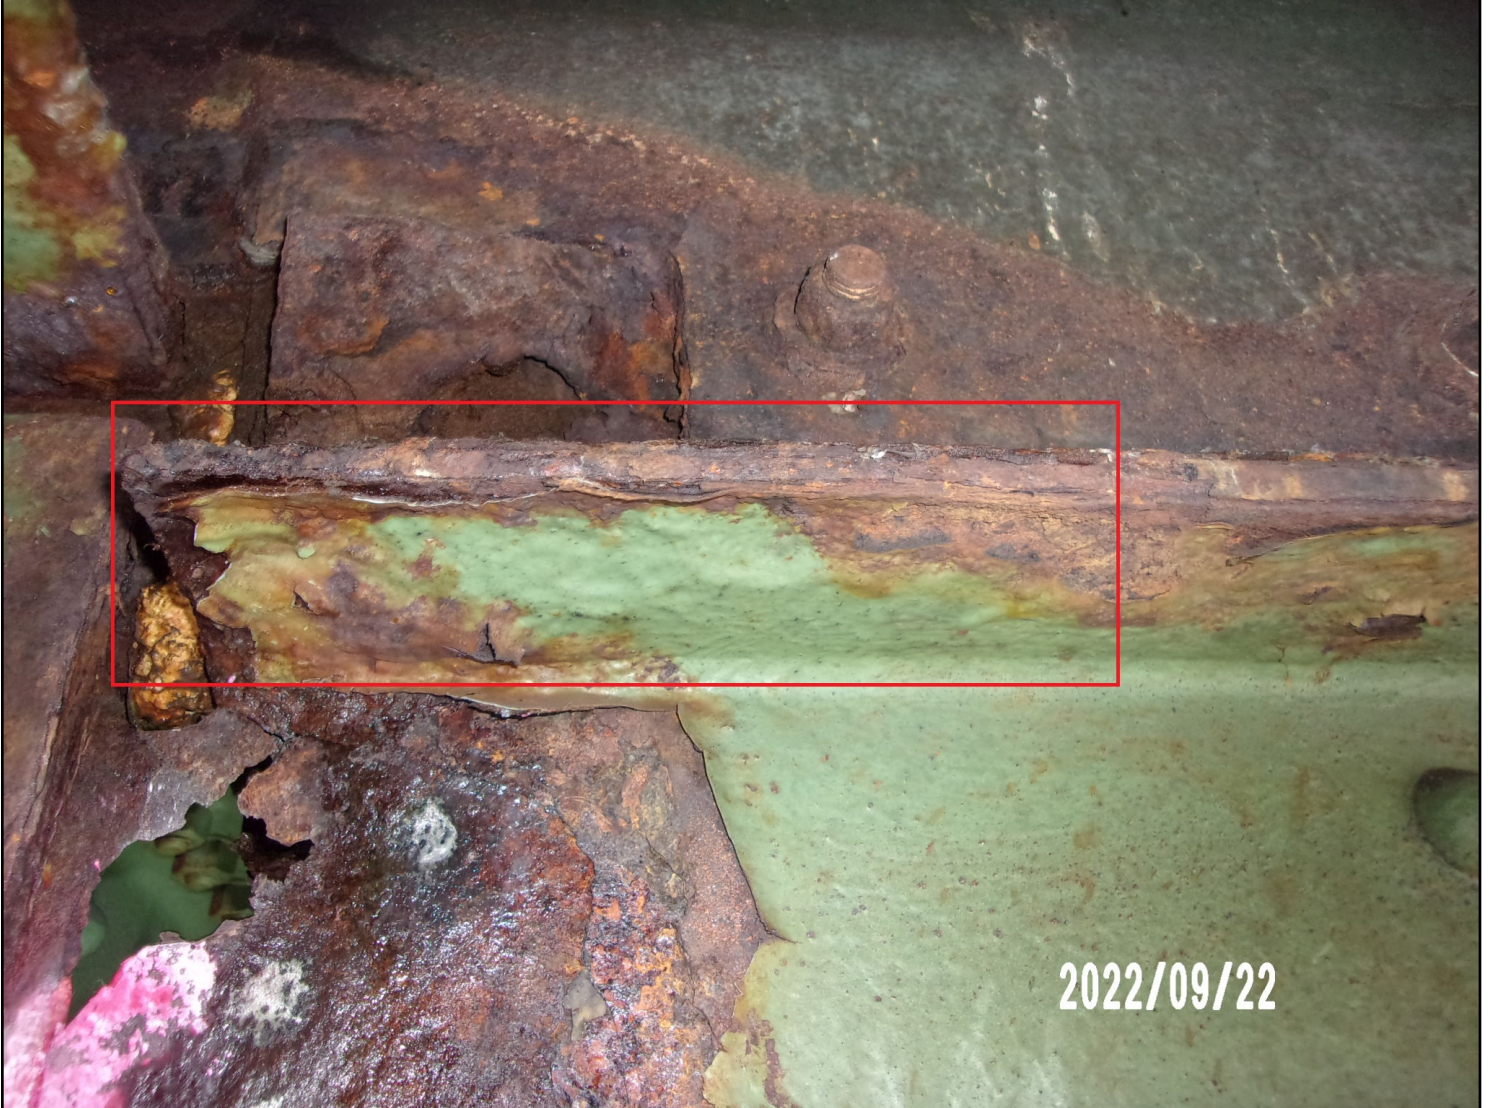
Photo Number: 9

Attachment Description: The right face of Stringer S2 in Span 58 at Pier 57. The right side top flange exhibits 30% section loss at the edge of the flange. Looking Left.

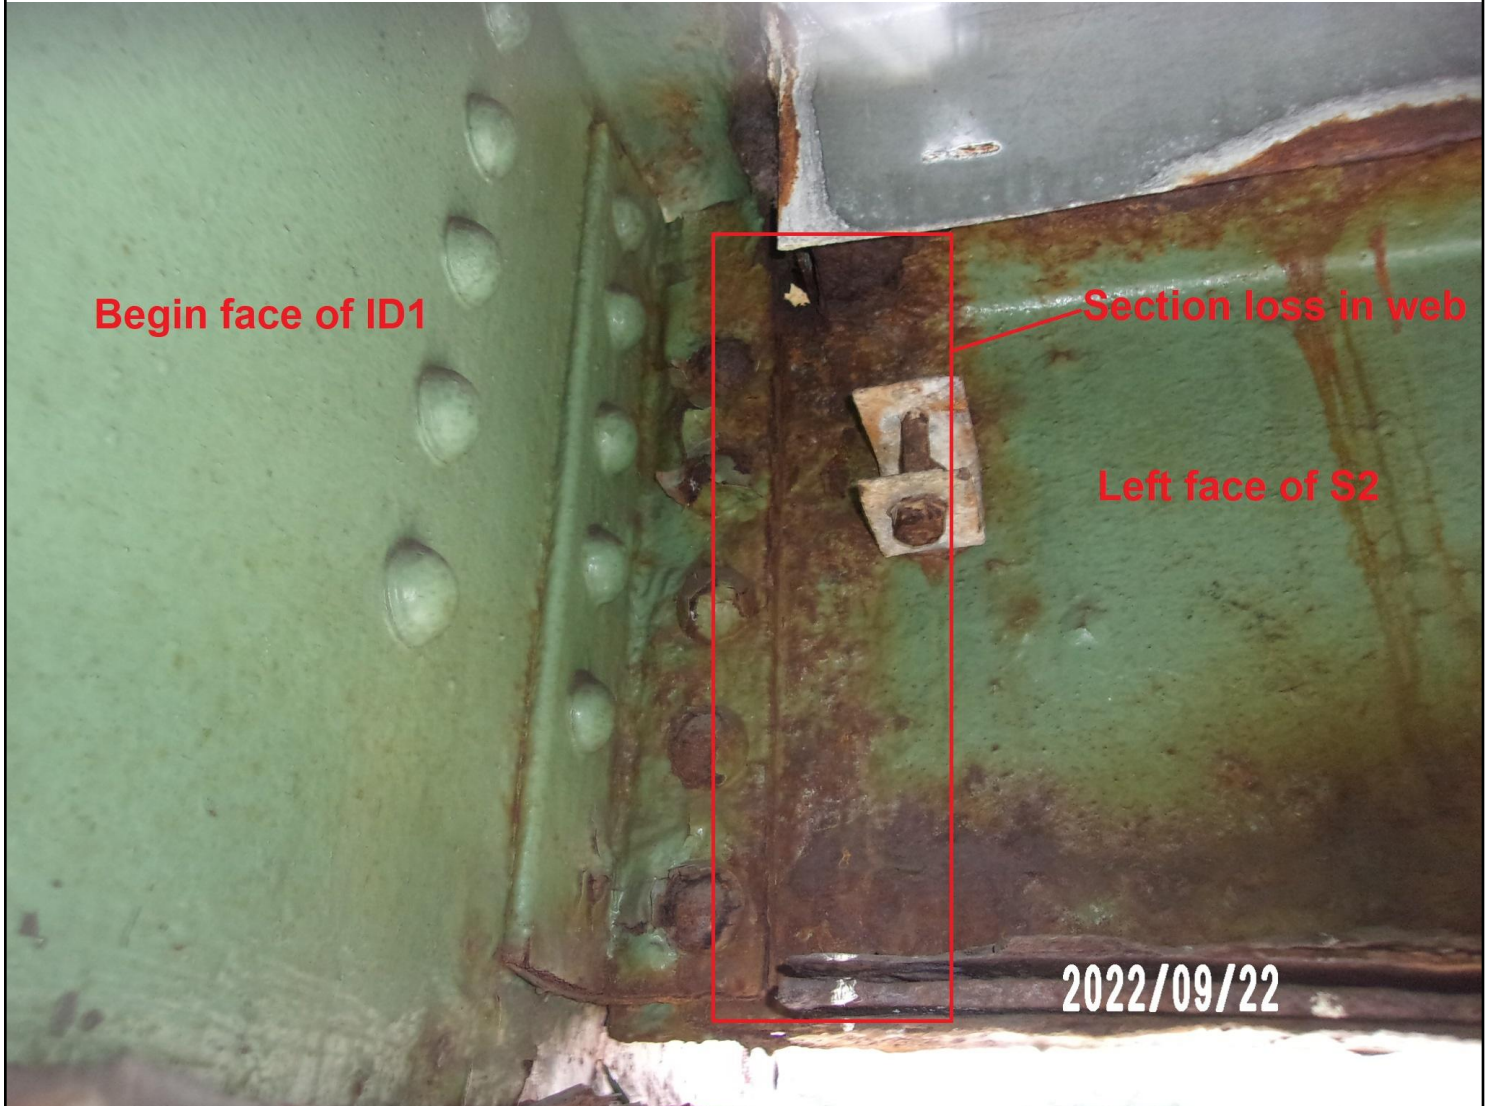
Photo Number: 10

Attachment Description: The left face of Stringer S2 in Span 58 at Intermediate Diaphragm ID1. The end of the stringer exhibits up to 1/16" section loss for the full web height along the connection angle. Looking Right.
